1 Warning, read this first !!!

2 Automatic update

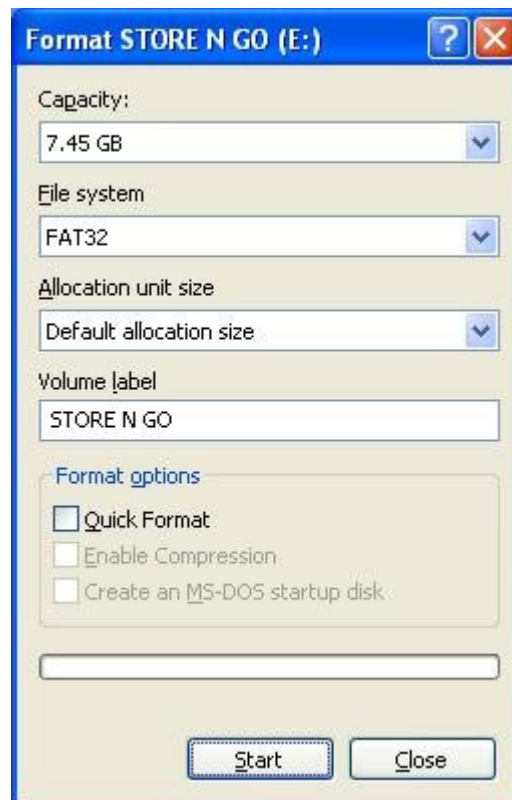
1. Get a new USB-Stick and format it with FAT32
(**Attention: All Data on the stick will be lost !!!**)

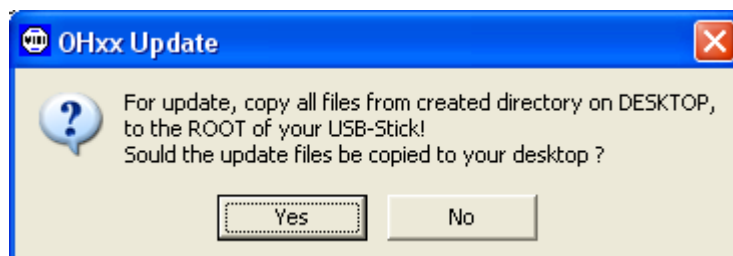
2. Download update file from WISI homepage and start it to extract update files to desktop

Press Yes to start extracting files.

The files will now be extracted to a OH_Update_Release directory on your desktop.

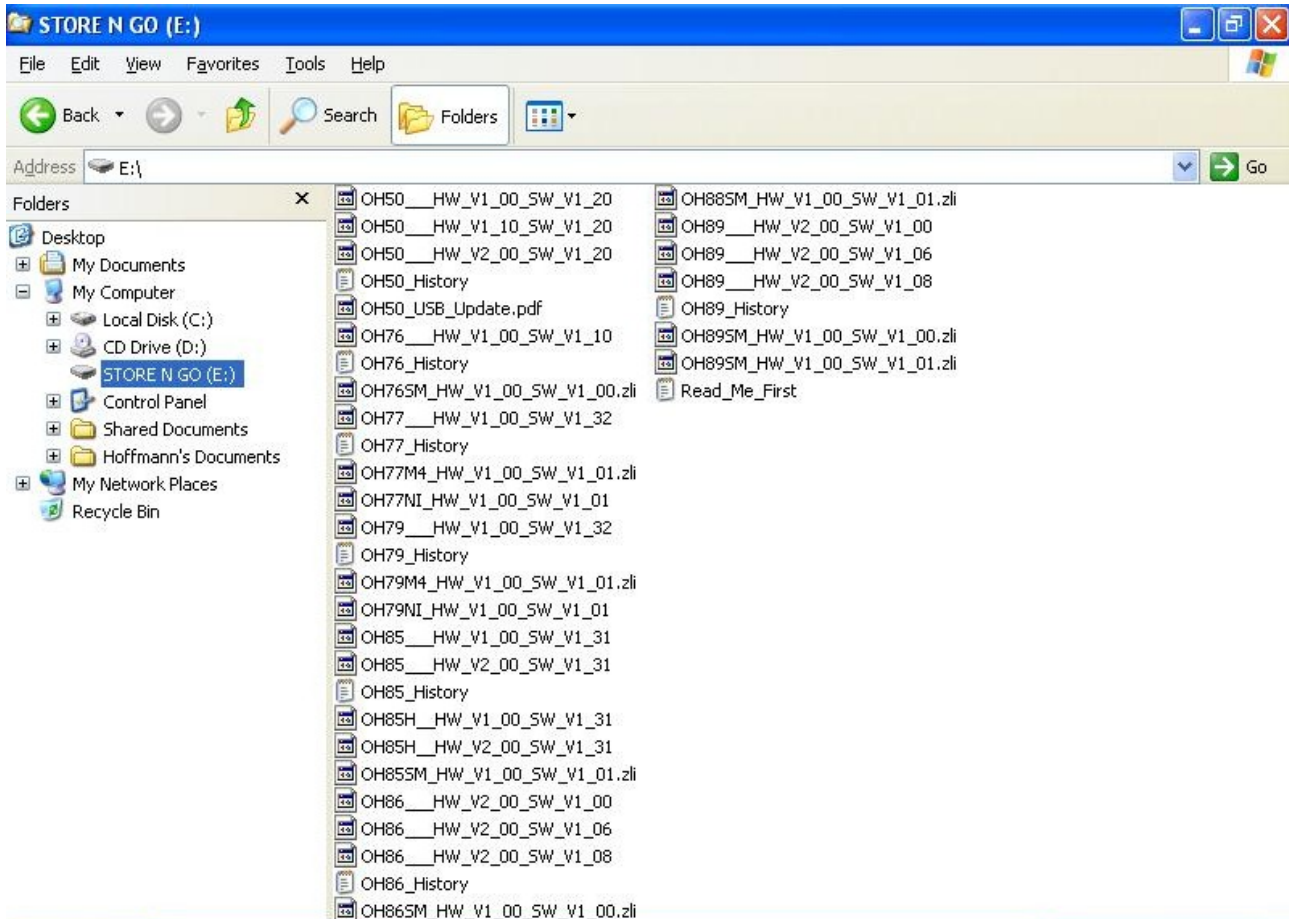
3. Mark all files in the created directory and copy them to the root directory of the USB-Stick. Your Stick should now look like this:
